ENVIRONMENTAL INCIDENT REPORT

VINTAGE PRODUCTION CALIFORNIA LLC
TAR CREEK CRUDE OIL AND PRODUCED WATER SPILLS

**30 JANUARY 2007
AND
6 FEBRUARY 2007**

**PREPARED BY JOSH CURTIS - ENVIRONMENTAL SCIENTIST
DEPARTMENT OF FISH & GAME, OFFICE OF SPILL PREVENTION AND RESPONSE
19 JUNE 2007**

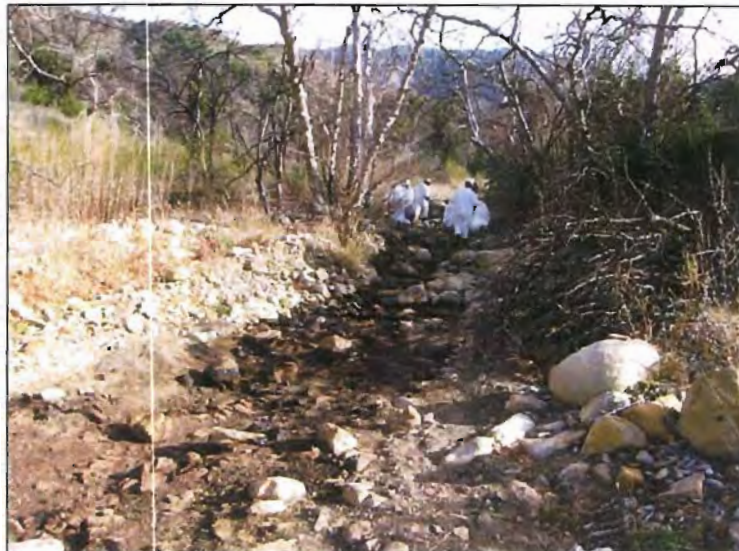
Picture 1- Surface flows in Segment 5 were not present in channel by the time the cleanup got underway. Spilled oil became stranded on/in streambed as natural stream flows diminished. ACTI work crews were clearing debris from low-flow channel to facilitate cleanup and to prevent underflow dams from clogging in case of rain. (pic id: 228_kw, pic date: 02/06/07)

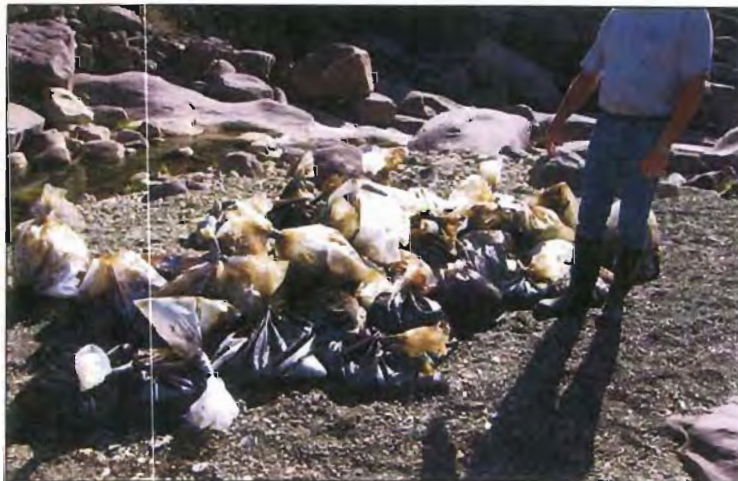
Picture 2 - Oil filled bags from vicinity of Segment 11. Awaiting helicopter pickup. (pic id: 215_kw, pic date: 02/06/07)

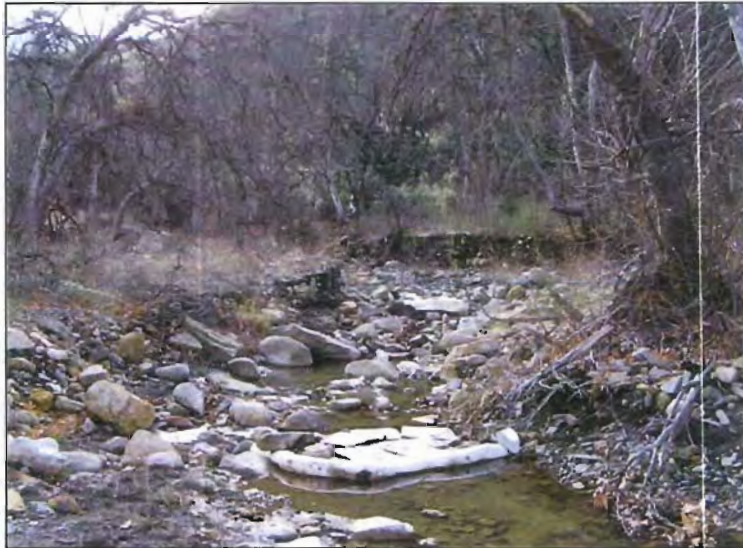
Picture 3 – Typical habitat upstream of Segment 10. Boom and sorbent pads are seen in creek. (pic id: P2010069, pic date: 02/01/07)

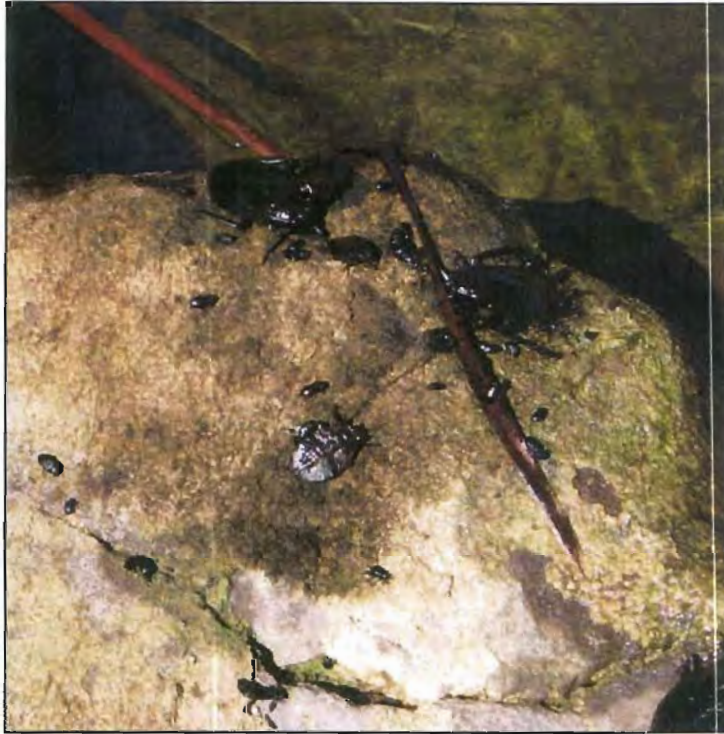
Picture 4 - Seven Belostomids and 29 unidentified beetles in a 10-cm square area. All are oiled and dead. (pic id: 167_kw, pic date: 02/03/07)

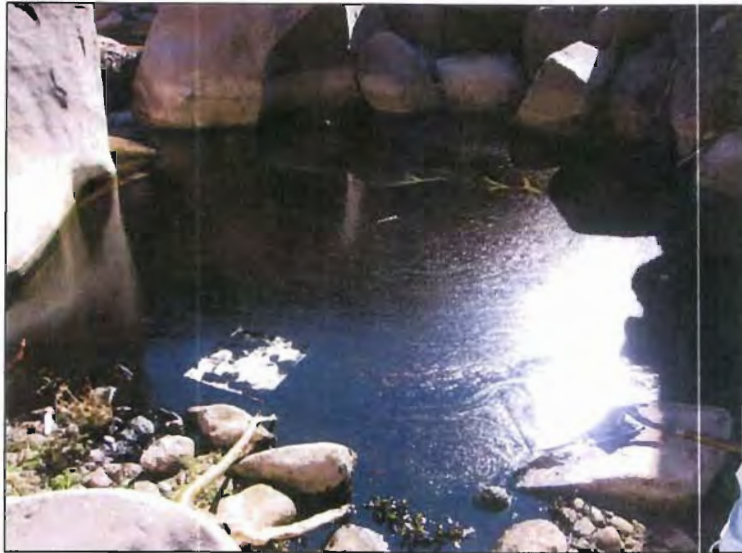
Picture 5 - View of dense black oil pad covering 80% of a 16x15 ft pool. Oil pad was so thick it was shoveled into bags. Dozens of dead oiled Belostomids in this area. (pic id: 158_kw, pic date: 02/03/07)
