ENVIRONMENTAL INCIDENT REPORT

VINTAGE PRODUCTION CALIFORNIA LLC
TAR CREEK CRUDE OIL AND PRODUCED WATER SPILLS

**30 JANUARY 2007
AND
6 FEBRUARY 2007**

**PREPARED BY JOSH CURTIS - ENVIRONMENTAL SCIENTIST
DEPARTMENT OF FISH & GAME, OFFICE OF SPILL PREVENTION AND RESPONSE
19 JUNE 2007**

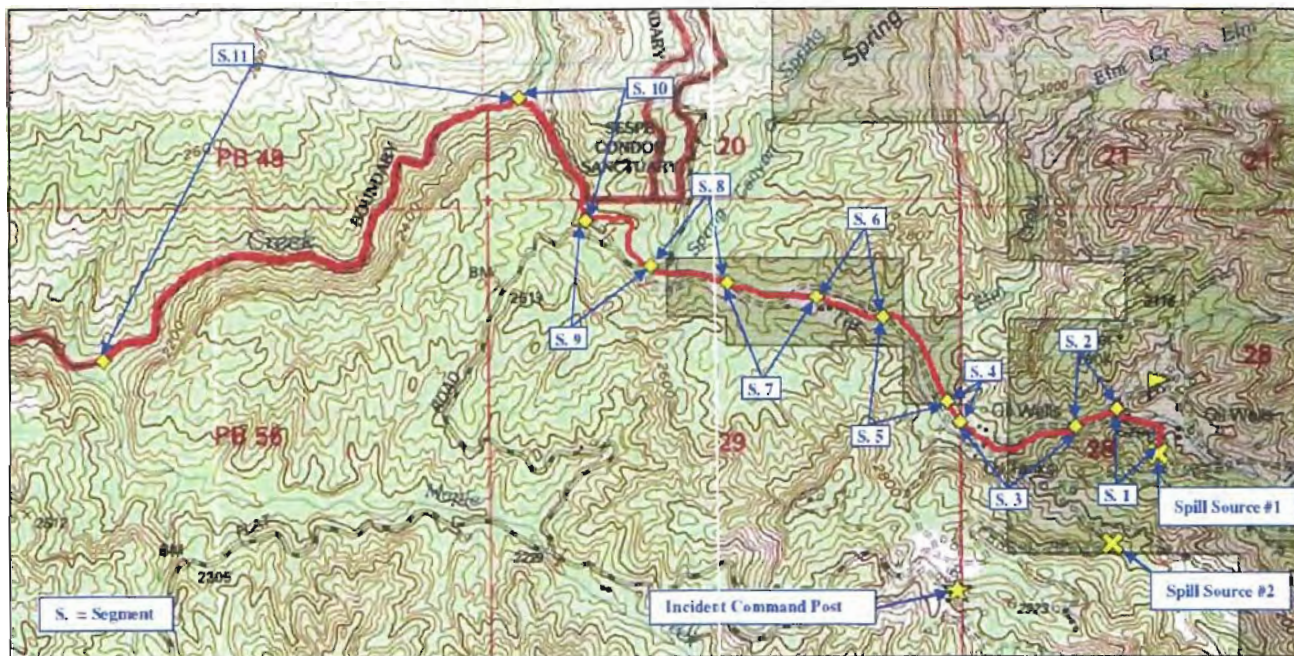
Map 1 - Overview of Spill Path and Response Segments

Spills: The first spill (OES# 07-0625) arose from a break in a transfer line. Spilled material entered the actively flowing Tar Creek and significantly oiled at least 3.21 miles of this waterway between the broken pipeline and just upstream of the confluence of Tar and Maple Creeks. The second spill (OES# 07-0844) was from the same transfer line but was not discovered until one week after the original incident. Most of the spilled material from this spill soaked into sediments surrounding the transfer line which was buried at the spill source. Some material flowed down a dry creek bed and contaminated approximately 100 feet of stream above a road culvert but did not enter the culvert or the actively flowing stream below.

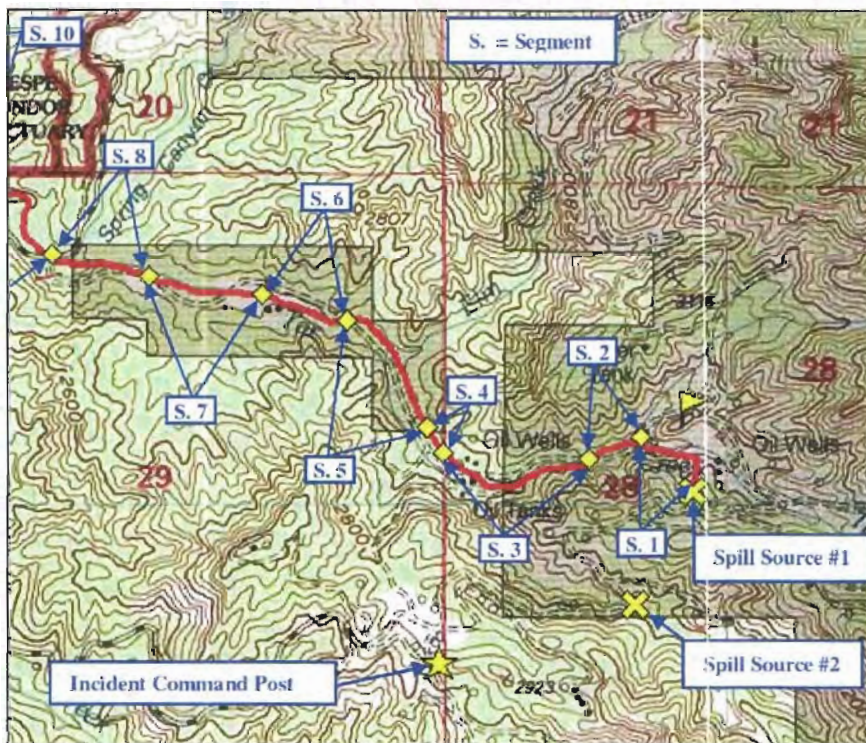
Map 2 – Close-up of Spill Path and Response Segments 1 – 8

The upper portion of the spill path was characterized by a steeply sloped 2-3 ft wide channel with intermittent flows. This area supported annual and perennial grasses and resprouting chaparral vegetation (recovering from previous wildfires). The lower portion of segment 1 was bordered on the south side by an overstory of oaks. The spill path entered an actively flowing unnamed, intermittent tributary to Tar Creek just upstream of the first road crossing. The unnamed tributary joined with Tar Creek in the immediate vicinity of the first road crossing.

Crowded between the roadway and a steep north facing cliff, the canyon and streambed were relatively narrow in Segment 2 and upper portion of Segment 3. Active stream flows were observed within this reach. This area was characterized by a sparse overstory of previously-burned California sycamores and a sparse to moderate understory of willows where water and sunlight were adequate. Little or no aquatic vegetation was present.

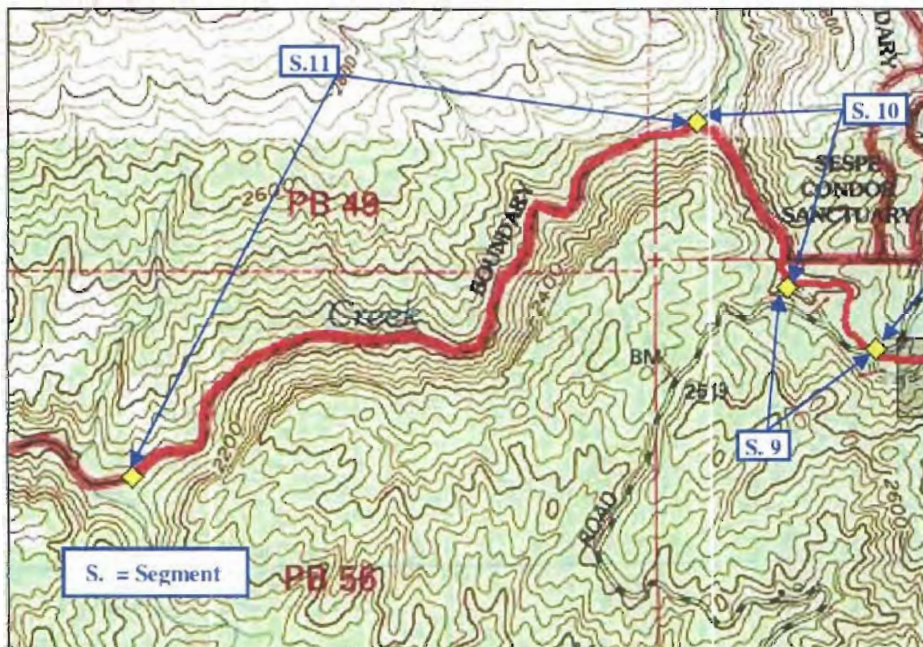
Map 3 - Close-up of Spill Path and Response Segments 9 – 11

Extending downstream from the last underflow dam at road end to Redrock Creek, this area was only accessible by foot. The streambed of Tar Creek narrowed as the canyon once again narrowed. This area had a trace overstory of previously burned sycamores and shrubs. Stands of willows were noted streamside. Where shale sands occurred, aquatic vegetation covered shallow pooled areas along 10 to 25% of the shorelines. Common Macroinvertebrates included but were not limited to: ferocious water bugs, water boatmen, at least two species of adult beetles, water striders, and aquatic larvae of flying insects (mosquitoes and dragon flies).

Accessible only by foot, this segment extended downstream from Redrock Creek to Maple Creek. The area was surrounded by steep canyon walls and hillsides which often cut through sandstone bedrock and clay sills. Where the canyon was narrow, the stream channel ran through sluices carved into bedrock outcroppings. Here there were pools 4 to 6 foot in depth. Where the canyon walls were further apart, boulder, cobble, gravel, and shale sand alluvia were observed and the streambed was 6 to 30 feet in width. Shrubby willows and mulefat were sparsely distributed through the portions of Segment 11 where alluvial deposits had more sand and gravel. Few mature trees occurred within the streambed or on its banks in this area, because these areas are subject to severe flash flooding and debris flows.
